Solving Erosion-Related Thermowell Failures

Thermowell Corrosion

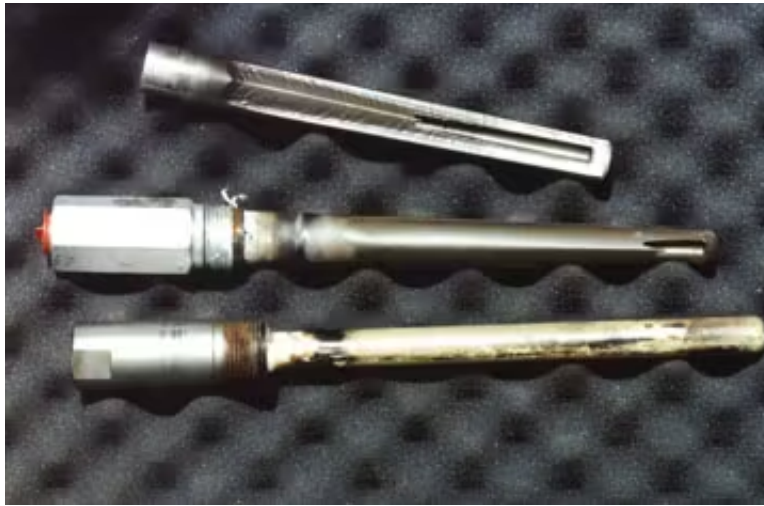
Figure 1. *The top two thermowells failed open due to corrosion in coal pulverizing line despite cobalt hard face coating. The protection tube on bottom survived without failure despite longer exposure in process.*

The three thermowells in Figure 1 were each installed into a coal pulverizing line where the major length of the thermowell shank was directly exposed to high velocity small particle erosion. The top two wells were coated with a cobalt-based hard facing to increase the lifespan of the thermowells. Although the hard facing material is much harder than steel, the

coating process leaves microscopic imperfections or cracks, which are inevitably revealed in a process where billions of grains of powder are blasted against the thermowell shank. Once the imperfection is exploited by the coal powder, bare metal is revealed and the thermowell quickly erodes as demonstrated in Figure 1.

The top two thermowells had been installed in the thermowell line for six months and three months respectively. Each was hard faced, and solid particle erosion completely opened their shanks. The thermowell at the bottom was a child of necessity and was installed in the coal pulverizing line for more than a year. Prolonged exposure to the flow of pulverized coal caused no damage to the thermowell or the reliability of the temperature measurement obtained from this installation.

The solution identified was to utilize a solid ceramic with a metallic support structure. Because the ceramic utilized was a solid ($\approx .125"$ thick) rather than a facing, it did not have the imperfections existing in a coating. The resulting difference in performance was dramatic. Protection tubes manufactured in this manner, such as the one at the bottom of Figure 1, have lasted for six years and more without failure at less than half the per thermowell cost of the hard-faced thermowells, which rarely lasted six months in the same installation.

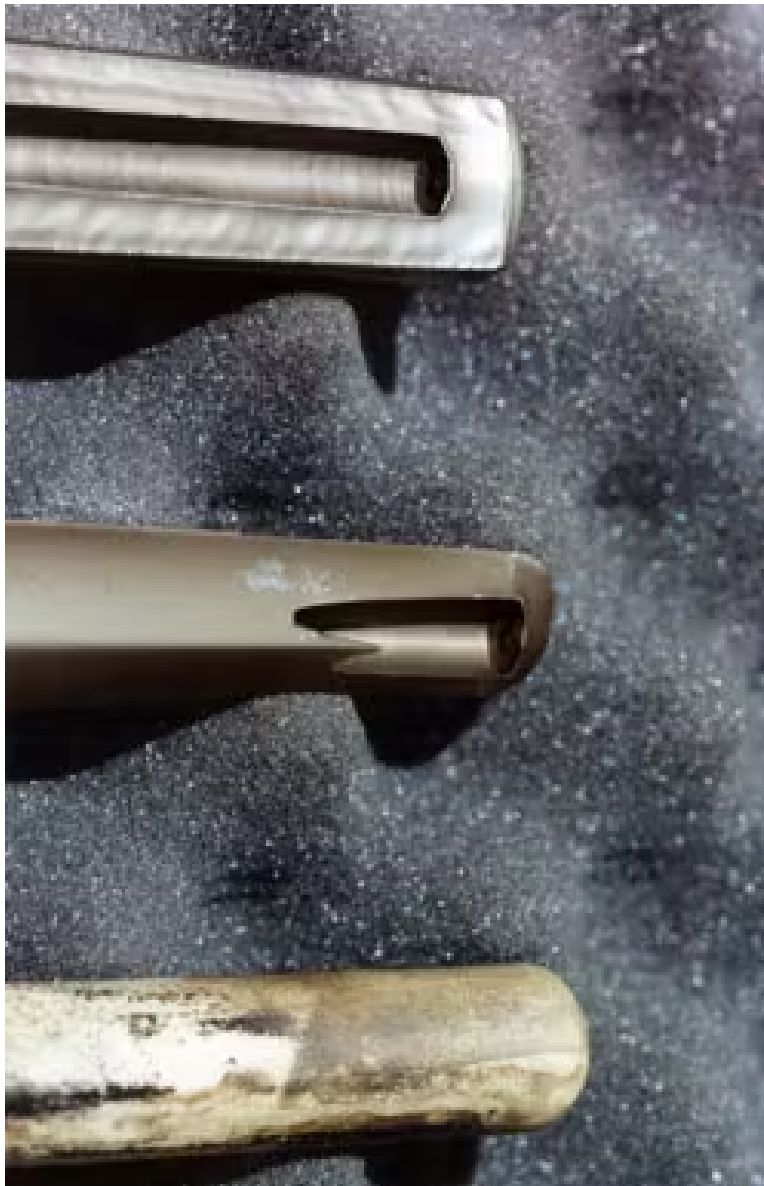
Figure 2. Eroded tips of thermowells in a duct application.
